# Study and Restoration of the Zeyrek Camii in Istanbul:

## First Report, 1997–98

ROBERT OUSTERHOUT, ZEYNEP AHUNBAY, AND METIN AHUNBAY

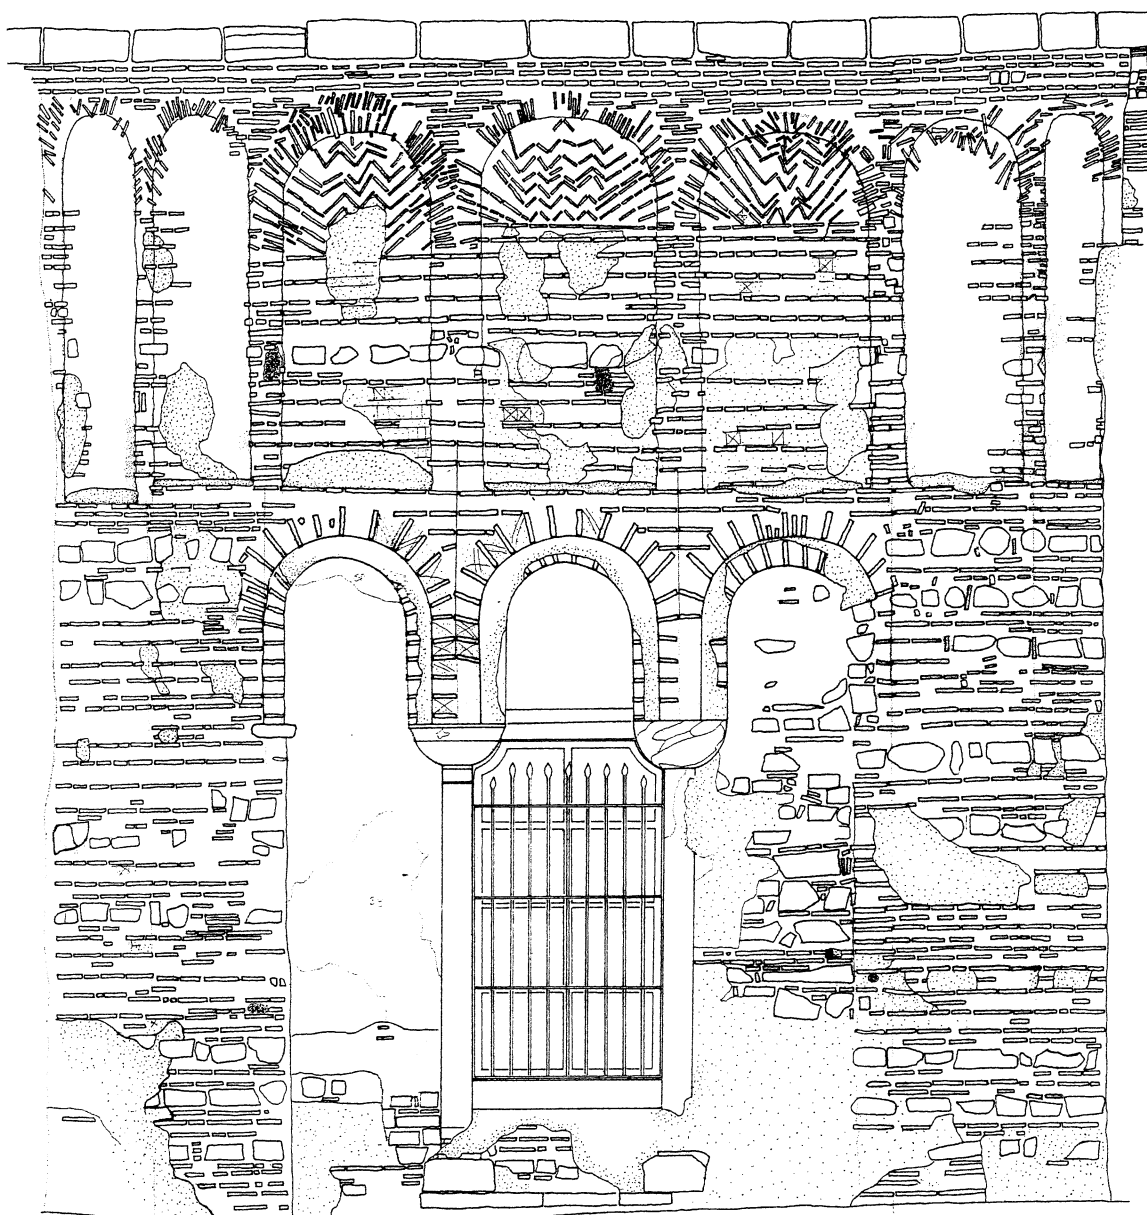
4 Zeyrek Camii, Middle Building, detailed elevation of east facade, 1998

The examination of the eastern facade of the Middle Building indicated that it had been repaired several times in the past (Fig. 4). At present the wall is damaged by the loss of bonding mortar at its joints and by the accumulation of soot. Some of the stone has also deteriorated. The capital of the north column is cracked, and its surface is eroded. Two of the apse windows are blocked, and the remaining one much reduced. During the work in this area, the damage was recorded, and a tentative proposal for the restoration was developed. To implement the project, we needed the analysis of mortars and plasters from this surface, as well as expert advice for cleaning the brick, limestone, and marble. Specialists from the Ministry of Culture's Central Laboratory for Conservation and Restoration are now addressing these problems.

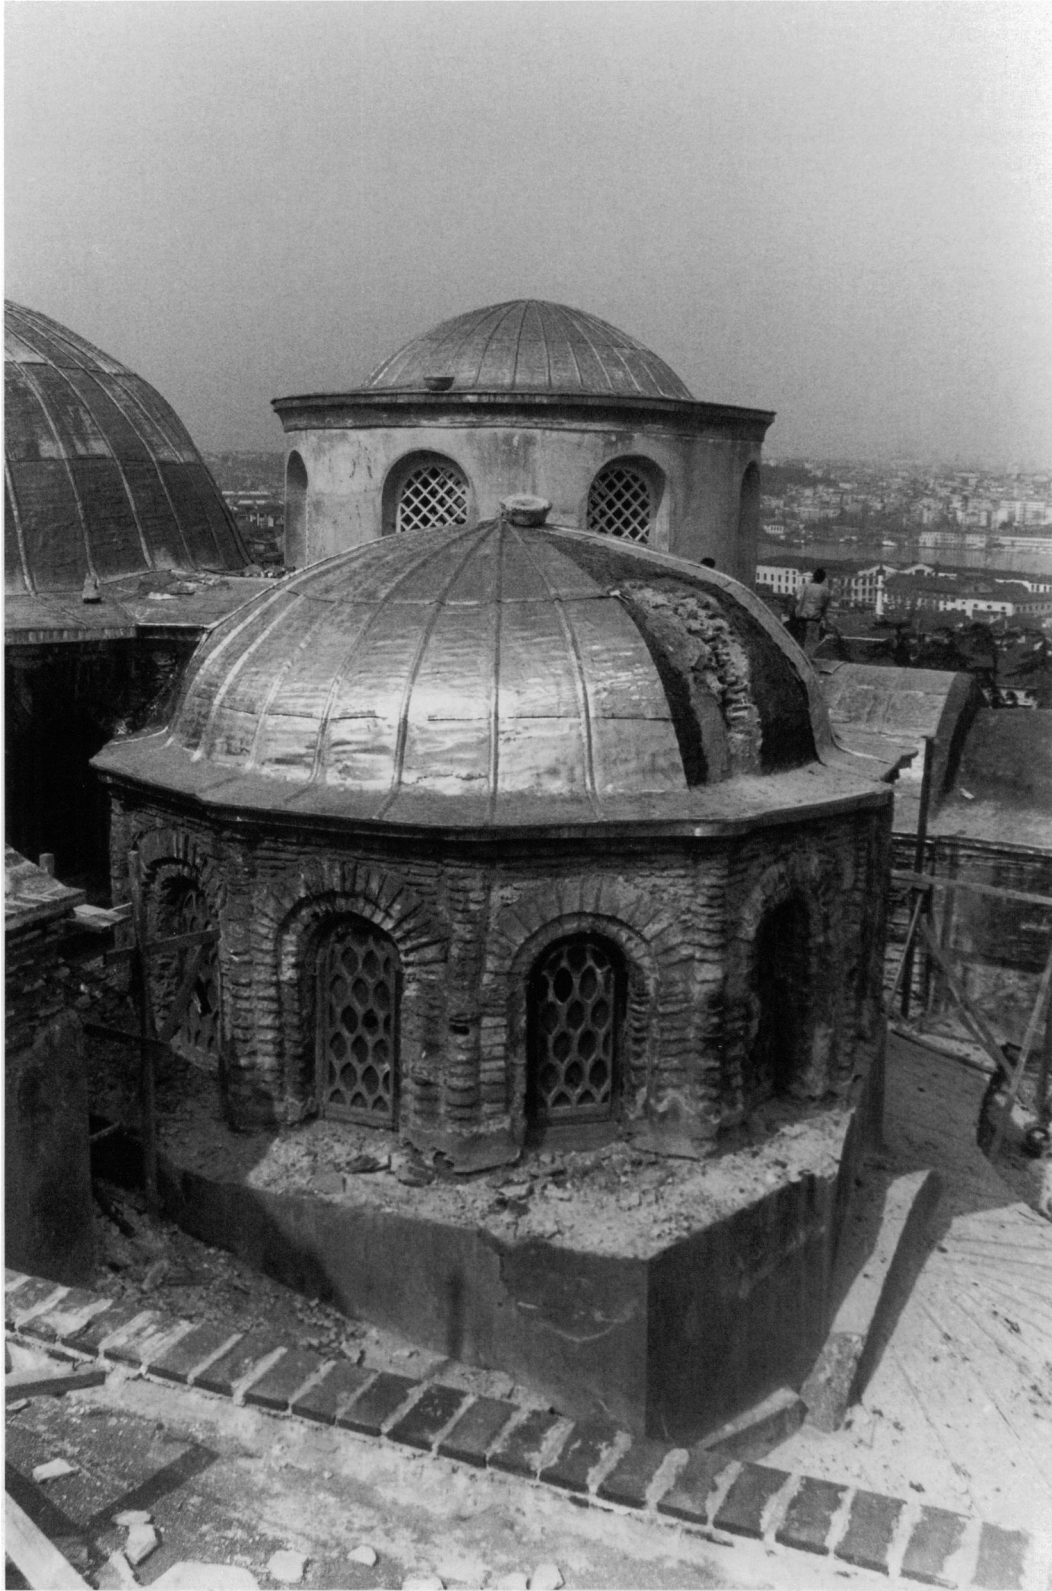
8 Zeyrek Camii, view from South Building, looking north, showing roofing in progress and eastern dome of Middle Building during repair, 1998

Eight cracks at the base of the western dome of the South Building and one major crack over the eastern dome of the Middle Building (Fig. 8) were similarly treated. A crack running parallel to the north wall of the North Building became visible after the fill over the prothesis was removed. It had been previously stitched with lime mortar, and stone blocks had been placed over the crack. The old mortar had disintegrated, so the fracture was cleaned to a depth of 22 centimeters and filled with the repair mortar.

After the cleaning, repair, repointing, and replastering of the vaults and domes, a layer of mud plaster was spread over the finished surface, and lead sheeting 2 millimeters thick was fixed into place with nails (Fig. 8). Following traditional practices, the mud plaster provides a protective cushion beneath the lead roofing. In places where it was necessary to raise the roofline, ceramic sherds were used as fill material. As of August 1998, approximately 50 metric tons of lead had been applied, with an additional 10 metric tons necessary to complete the roof work. However, the roofing system over the western part of the building will require further study before it can be replaced (Fig. 2). The raised, reinforced concrete roof was added here in 1967, and a proposal must be presented to the Monuments Council before it can be removed. The modern brick columns and reinforced roof slabs exert concentrated loads onto the historic structure and may cause damage to it.

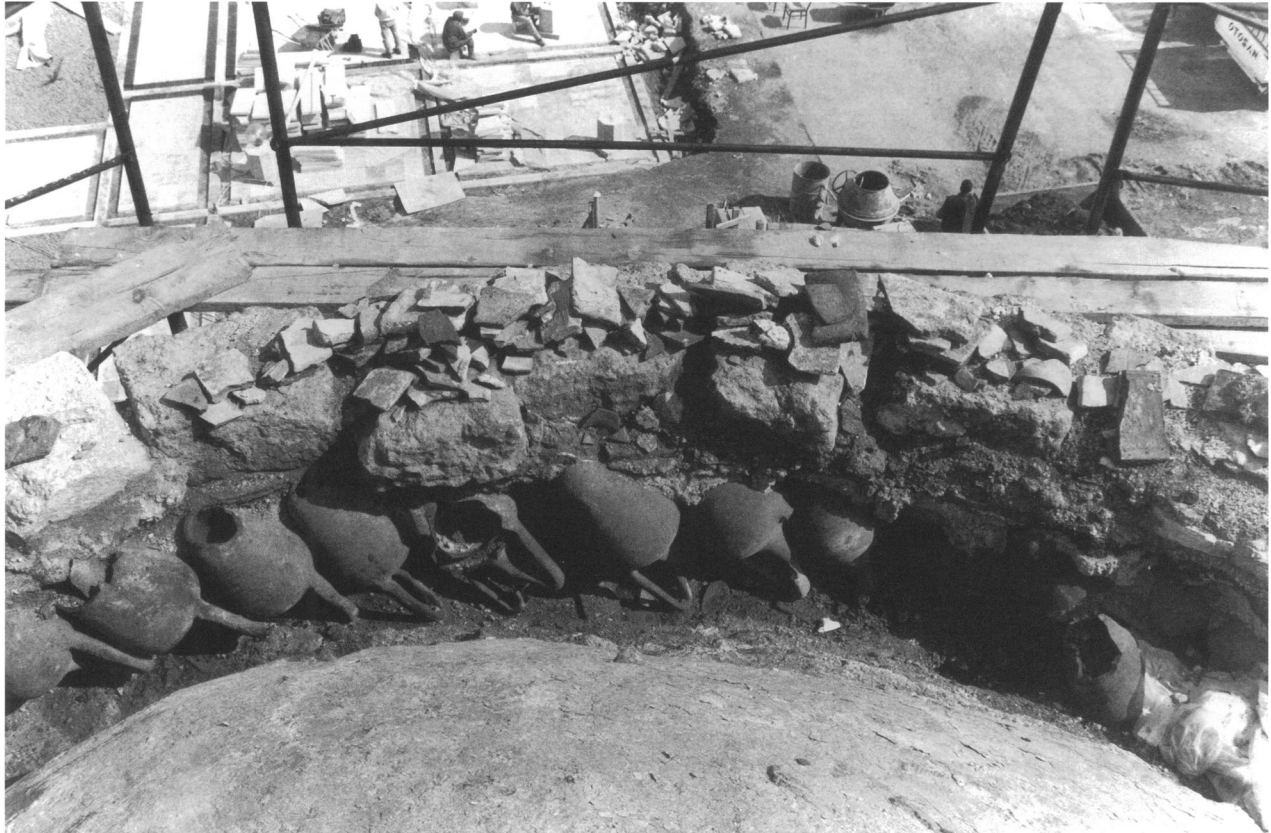
9 Zeyrek Camii, North Building, view toward the apse vault during cleaning, showing Byzantine amphorae in the fill behind the conch and Ottoman cornice blocks joined with iron ties, 1997

During the removal of the old roofing materials from the apse of the North Building, we encountered a packing of Byzantine amphorae embedded in ash and charcoal (Fig. 9). These had been employed during the original construction to fill the void between the apse semi-dome and the eastern wall.<sup>9</sup> A similar practice was observed in the eastern vault of the South Building. In addition, many large fragments of

The amphorae in the North Building were positioned upside-down, forming two parallel rows around the apse semidome (Fig. 9). The great majority were broken at their bases, probably during a previous restoration at the monument. Some sherds were mixed into the fill material around them, and the sherds proved useful in reconstructing the profiles of a number of broken amphorae.

This packing of amphorae on the North Building was carefully excavated by archaeologist Ayşin Özgül, whose report appears as an appendix to this study. Nineteen amphorae were removed, studied, and restored; they have now been deposited in the Museum of the Vakıflar in Istanbul. They were replaced by similar ceramic vessels of modern production before this area of the roof was recovered.
